NBS TECHNICAL NOTE 569

Hurricane Camille- August 1969

A Survey of Structural Damage
Along the Mississippi Gulf Coast

One week after Hurricane Camille devastated the Mississippi-Louisiana Gulf Coast with 125 mph winds and 20-ft tides on August 17, 1969, a four-man NBS team investigated the damage to buildings and other structures. This report presents photographic survey data from this investigation along with additional data on wind speeds and storm surge. Based on these data, suggestions are made pertaining to the improvement of building design and construction practices.

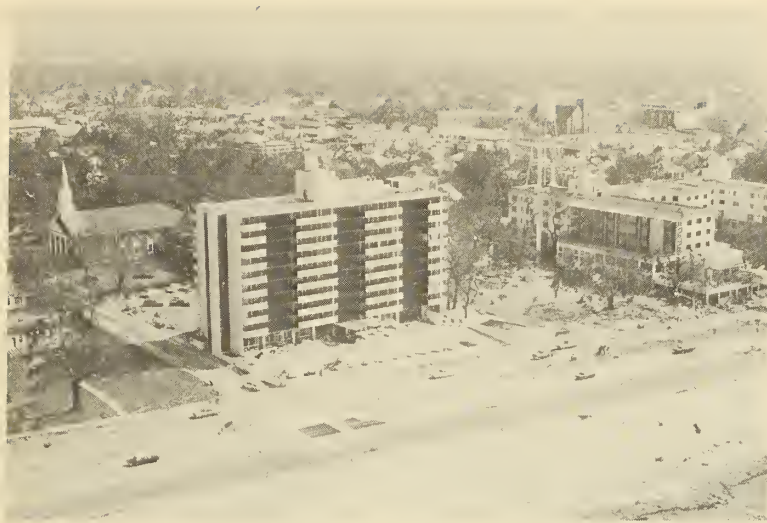
Structures on slightly higher ground fared much better even though their ground floors and basements were flooded (fig. 8). Generally, surge damage was limited to those areas within two blocks of the beach.

Figure 8. Coastal area, Biloxi, Mississippi.

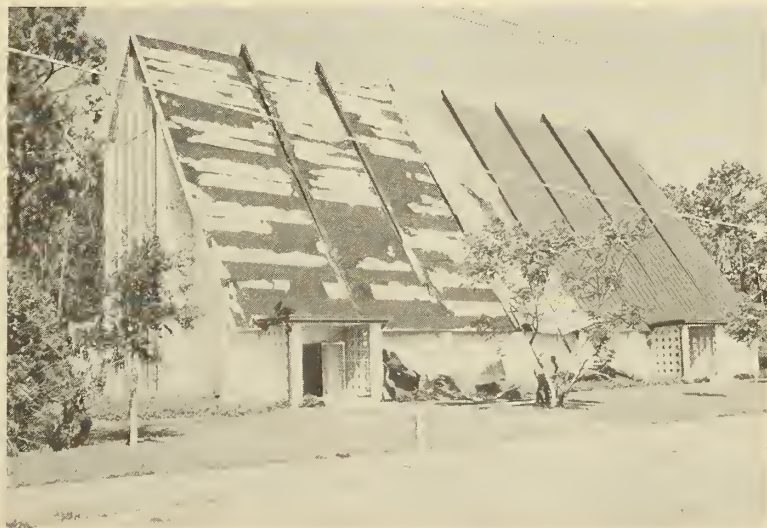
Figure 9. Chapel, Keesler Air Force Base, Biloxi.

Keesler Air Force Base - Damage to buildings was limited to loss of cladding and roofing with some flooding occurring in housing developments located along the back bay. The chapel shown in figure 9 suffered the most serious damage with the loss of copper roofing and subsequent water damage to the interior furnishings. Single-family dwellings with wind-resistant shingles exhibited very little damage (fig. 10).

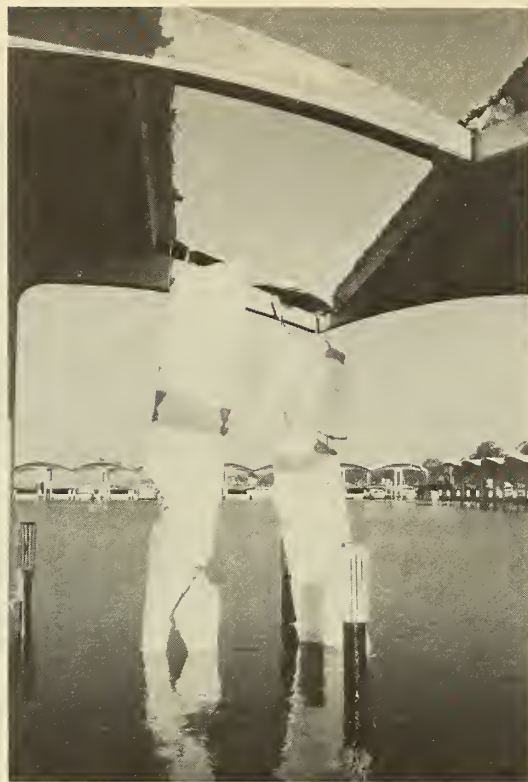
Broadwater Beach Marina - This marina (fig. 11) near Biloxi consists of reinforced concrete columns and double-T roof members over the boat slips. Although some of the roof members were damaged (fig. 12), the overall performance of the structure was very good considering that it was completely inundated by the storm surge. Surge height in this area (approximately half way between Biloxi and Gulfport) was about 20 ft.

Figure 12. Close-up view of damage to Broadwater Beach Marina.

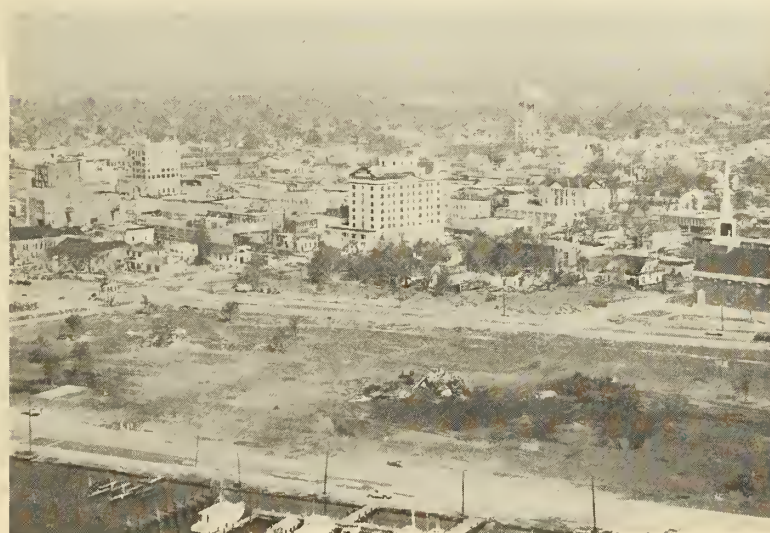
An aerial view showing a portion of the downtown business and commercial area of Gulfport is shown in figure 15. Many small buildings located along this flat coastal area were heavily damaged or destroyed by the

Figure 15. Business and commercial area, Gulfport, Mississippi.

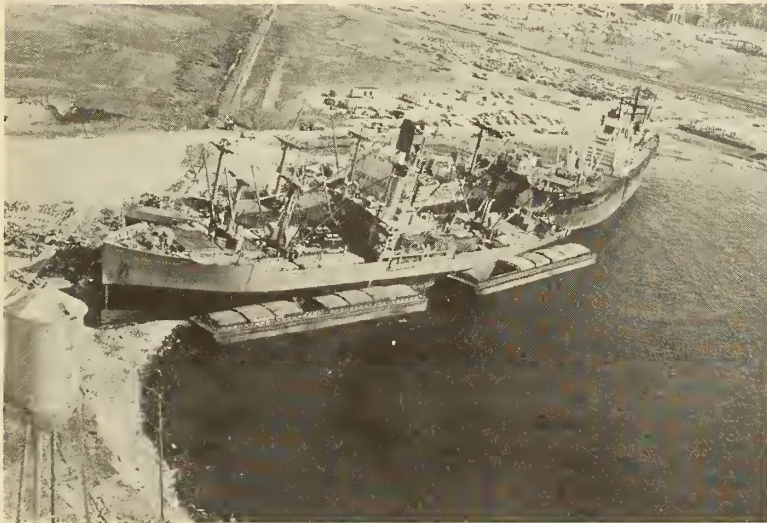
Three large ships, which were driven aground on the Gulfport Coast near the Mississippi Power Company building, are shown in figure 17.

Figure 17. Ships aground at Gulfport, Mississippi.

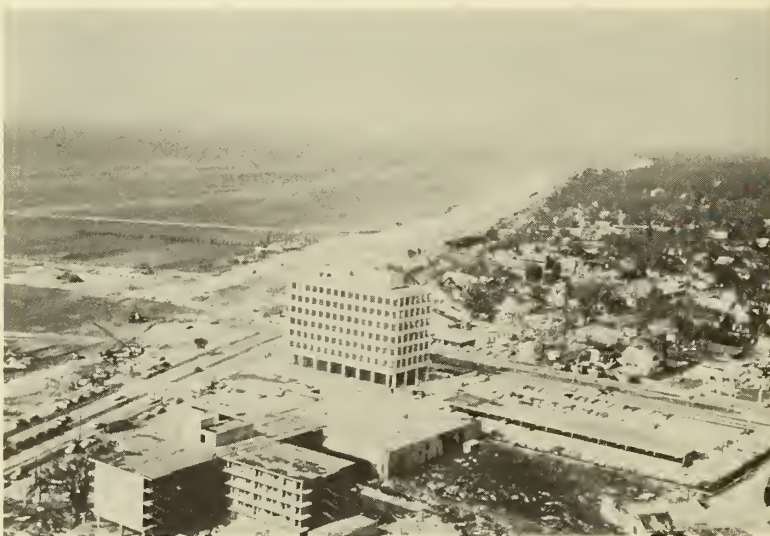
Mississippi Power Company - The new seven-story Mississippi Power Company building is located on U.S. Highway 90 in Gulfport. Figure 19 is an aerial view illustrating the proximity of the building to the coastline. Opened in April, 1969, this \$2.5 million concrete frame building sustained only minor damage. To help protect the building from flooding, it was situated on an elevated, earth-banked plaza-podium (about 26 ft above mean sea level).

Figure 19. Seven-story Mississippi Power Company building, Gulfport, Mississippi.

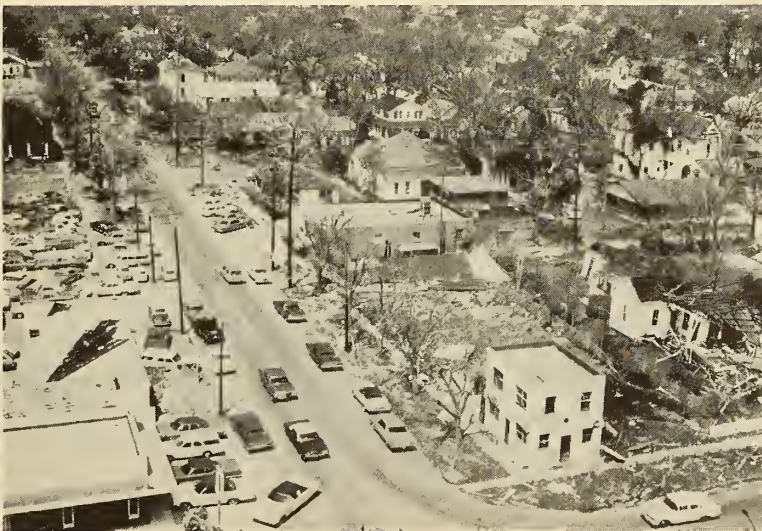
Figures 22 through 24 indicate the general level of damage in the area surrounding the Mississippi Power Company. The prefabricated metal building in figure 22 again points up the importance of local wind effects when designing roof elements. The random distribution of damage shown in figure 23 is typical of the entire area covered by the survey. Failures of roofing are usually progressive as is indicated in figure 24. Gravel from this built-up roof contributed considerably to the flying debris.

Figure 23. Area directly east of Mississippi Power Company building, Gulfport, Mississippi.

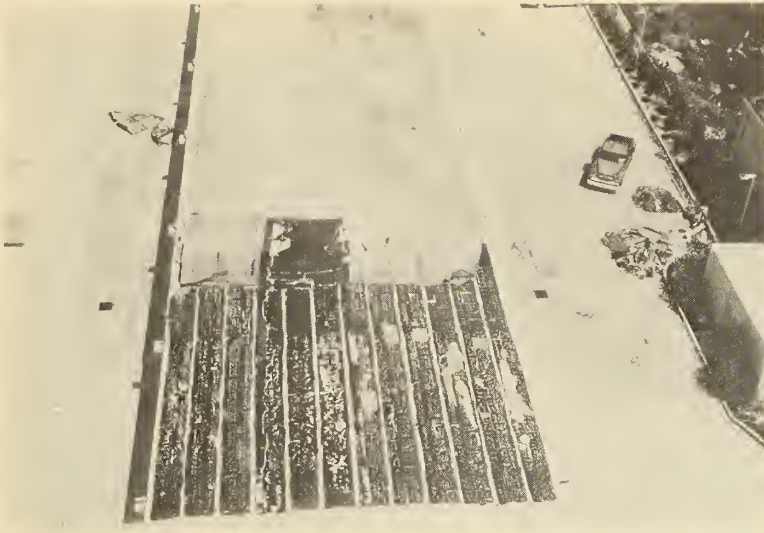
Figure 24. Roofing damage on building adjacent to north side of Mississippi Power Company building.

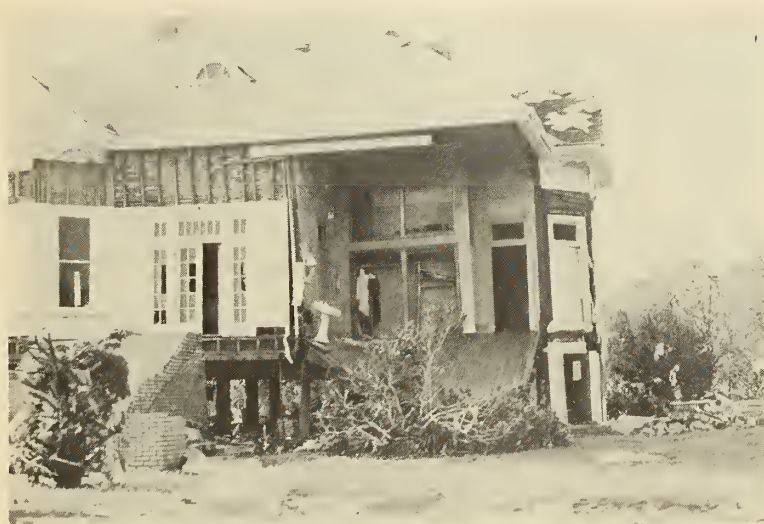
Wooden frame houses suffered relatively little wind damage, most damage being caused by wind-driven missiles and falling trees. The house shown in figure 25 was subjected to the direct action of waves and was probably battered by water-borne debris. The oil storage tank in figure 26 was carried inland on the surge from its original location on a pier in the port complex. The large dent indicates a collision with other structures while being driven ashore.

Figure 25. Wood-frame residence damaged by waves, Gulfport, Mississippi.

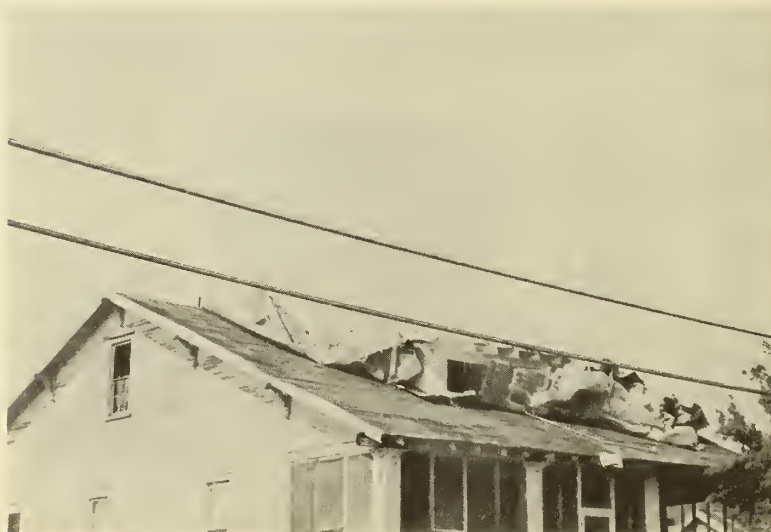
An old wood-frame house (fig. 27) escaped major damage except for its metal roof covering.

Figure 27. Metal roofing damage, Gulfport, Mississippi.

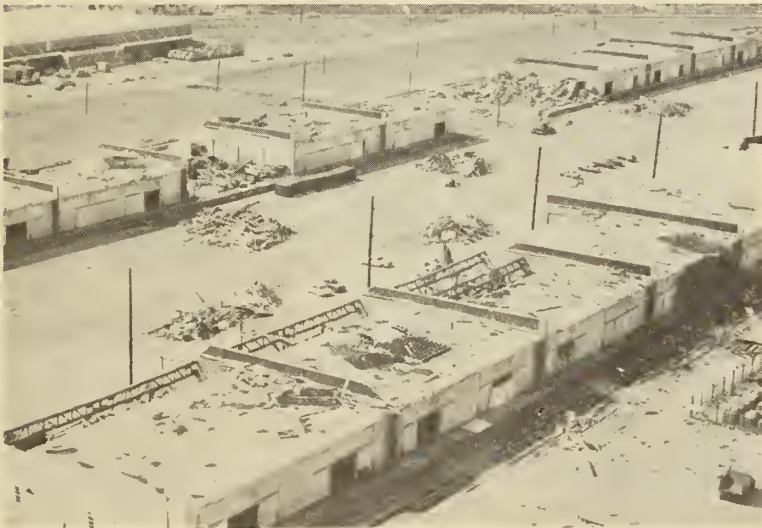
Figure 29. Damaged warehouses, U.S. Naval Construction Battalion Center, Gulfport, Mississippi.

An aerial view of the damaged warehouses is shown in figure 29. These wood-frame buildings were built during World War II and were still in daily use. The major damage to these structures occurred on the windward side. As shown in figure 29, the warehouse units were constructed with brick fire walls between each section. The roofs were supported by timber trusses and the front and back walls were of wood-frame construction. Close-up views illustrating the collapsed wood-frame walls, damaged brick fire walls and dislodged roof trusses are shown in figures 30 and 31.

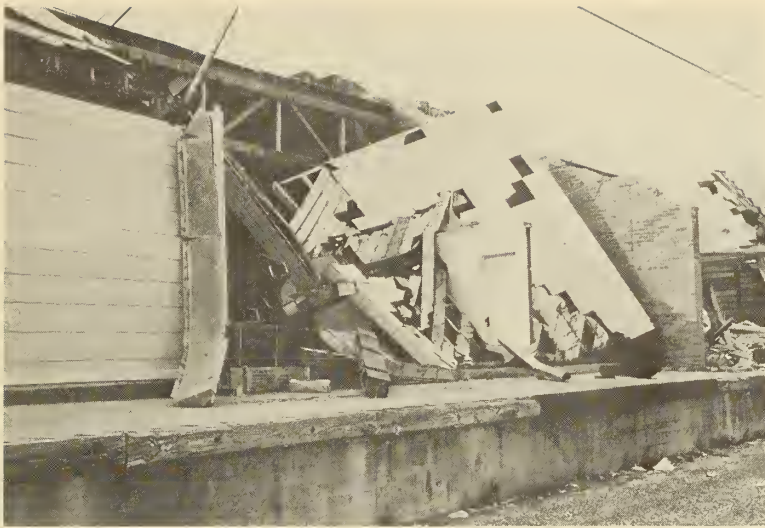
Figure 30. Close-up view of damaged warehouse shown in figure 29.

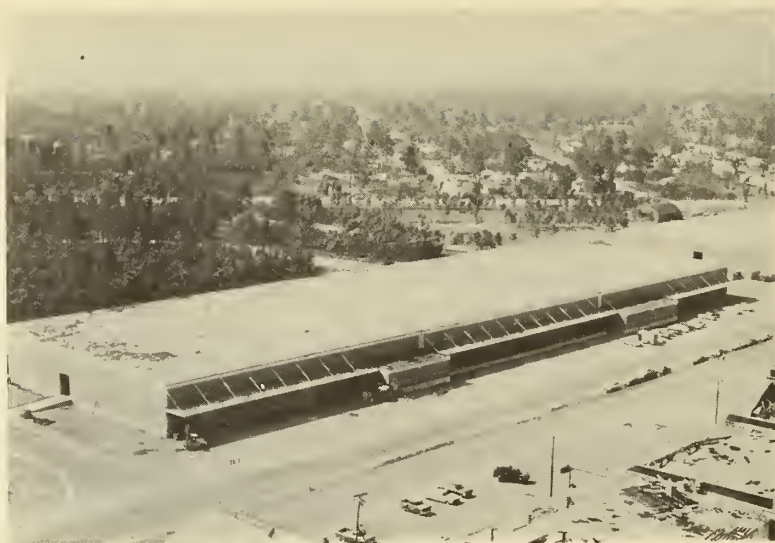
Comparatively minor damage was suffered by three reinforced concrete-masonry warehouses (fig. 32) which were built during or since 1950. These warehouses were located near the older wood-frame warehouses (see upper left of fig. 29). As shown in figure 33, these structures lost some 2-ft wide by 8-ft long precast concrete roof panels along the perimeter of the roof. It was observed that all roof panels were securely anchored at interior points by steel clips but no anchorage was provided for the perimeter panels, the location where peak uplift usually occurs. Prior to the passage of Hurricane Camille, it was reported to the NBS survey team that hundreds of civilian dependents left their homes to take refuge in these concrete-masonry warehouses.

Figure 32. Reinforced concrete and masonry warehouse, U.S. Naval C. B. Center, Gulfport.

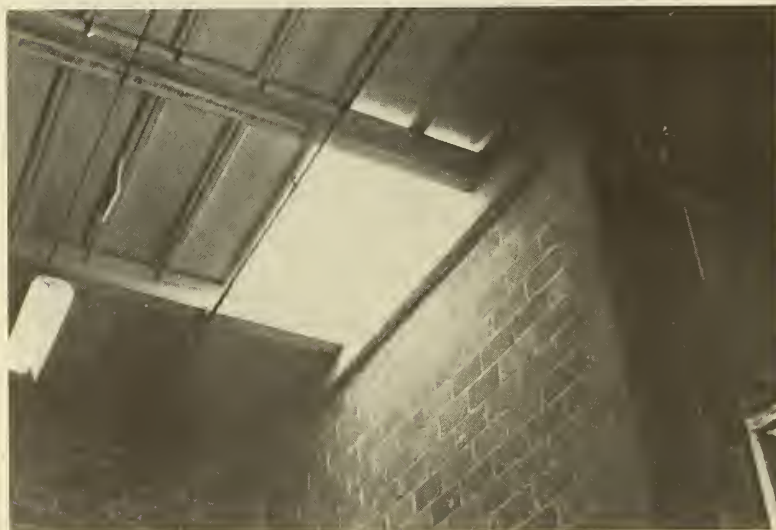
Figure 33. Precast concrete roof slabs, U.S. Naval C. B. Center warehouses, Gulfport, Mississippi.

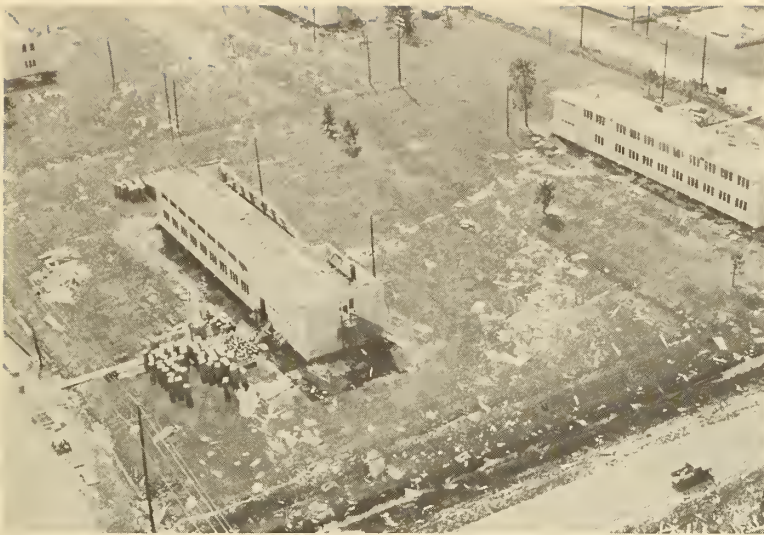
Severely damaged two-story wood-frame barracks and a one-story wood-frame warehouse are illustrated in figures 34 and 35. The type of damage observed from both the ground and the air seems to indicate this area was probably struck by tornadoes. Nearby, large pine trees were

Figure 34. Wood-frame barracks, U.S. Naval C. B. Center, Gulfport.

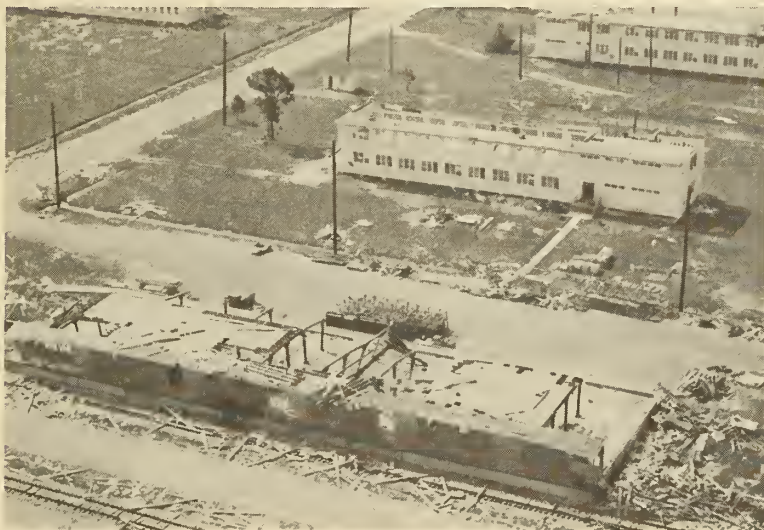
Figure 35. Wood-frame warehouse and barracks, U.S. Naval C. B. Center, Gulfport, Mississippi.

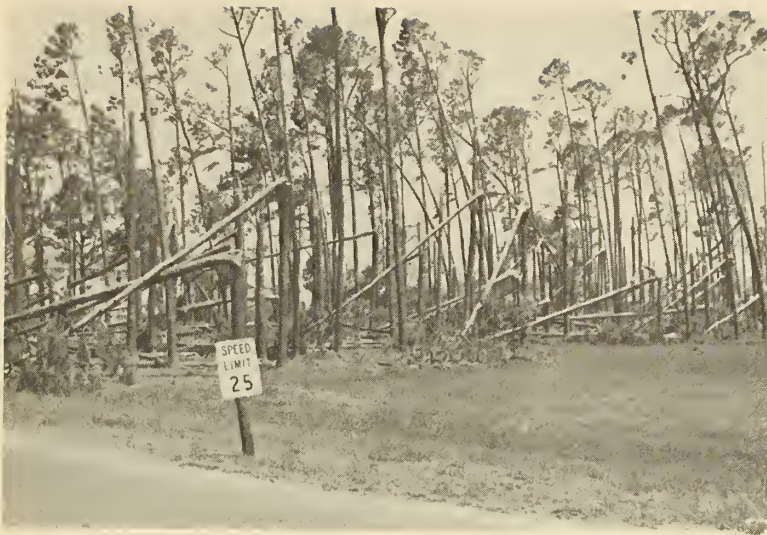
broken off some distance above the ground (fig. 36).

Figure 36. U.S. Naval C. B. Center, Gulfport.

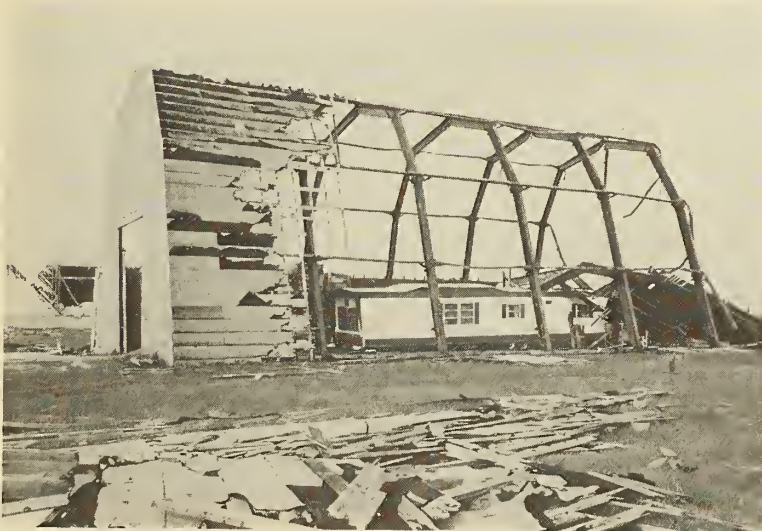
Figure 37 illustrates a steel-framed building which lost one end-wall and most of its light wood-frame cladding.

Figure 37. U.S. Naval C. B. Center, Gulfport, Mississippi.

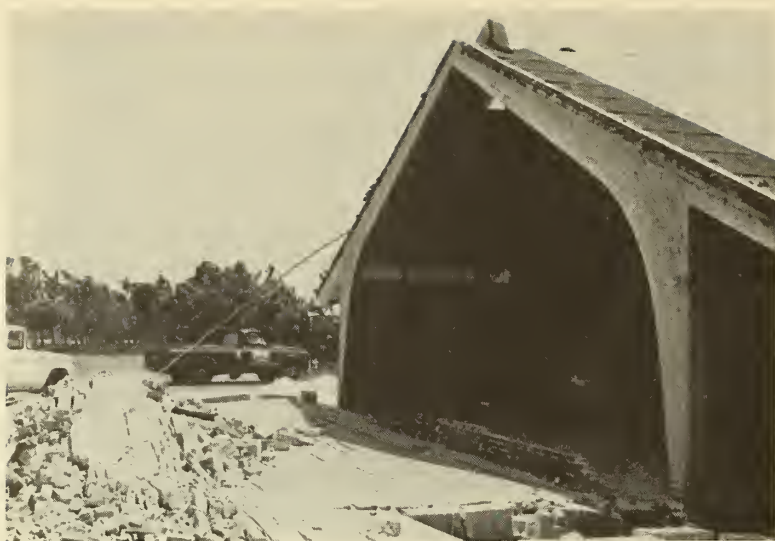
A 12-in thick masonry end wall of the new B.O.Q. building was also toppled during the hurricane (fig. 38). The forces causing the outward collapse of this wall were probably due to a combination of suction on the leeward side and a high internal pressure. However, an inspection of the construction indicated there were no metal anchors tying the wall to the adjacent laminated timber arches. Brick masonry columns at both ends of the wall contained vertical steel reinforcement, but this reinforcement extended only about 20 inches above the column base. Underneath the collapsed masonry wall (note hump in fig. 38) is a car which was parked by the owner in what he probably considered to be a sheltered and safe location. Other automobiles at the U.S. Naval Center were also damaged by flying debris (fig. 39).

Figure 38. Masonry wall damage, U.S. Naval C. B. Center, Gulfport.

The proper use of reinforced masonry walls in many buildings (figs. 31, 38, 45, 50) would probably have reduced some of the damage which was observed.

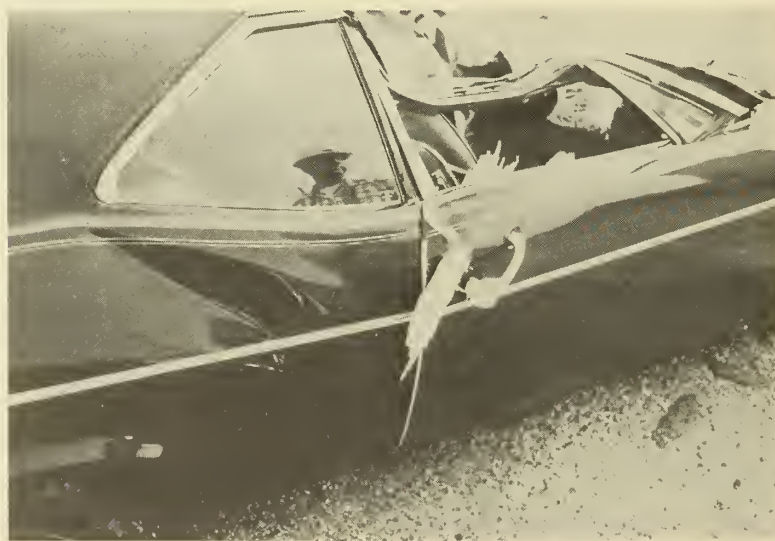
Figure 39. Damaged car, U.S. Naval C. B. Center, Gulfport, Mississippi.

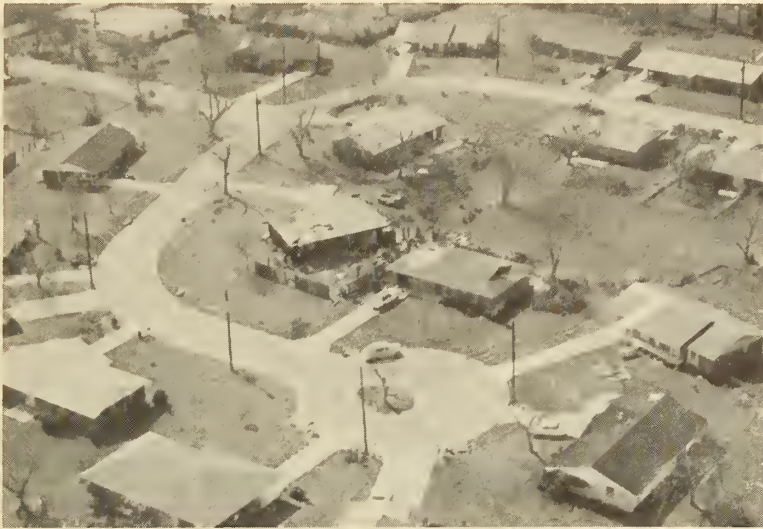
Figures 40 and 41 indicate the sporadic nature of wind damage in the area west of the U.S. Naval Center and north of Long Beach. Failures were usually initiated by loss of carport roofs or large roof overhangs which often led to removal of the complete roof structure.

Figure 40. Residential area west of Gulfport.

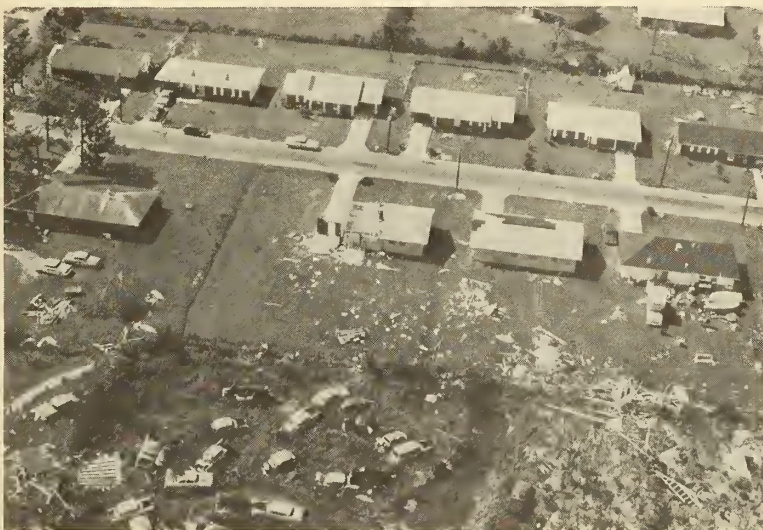
Figure 41. Residential area north of Long Beach, Mississippi.

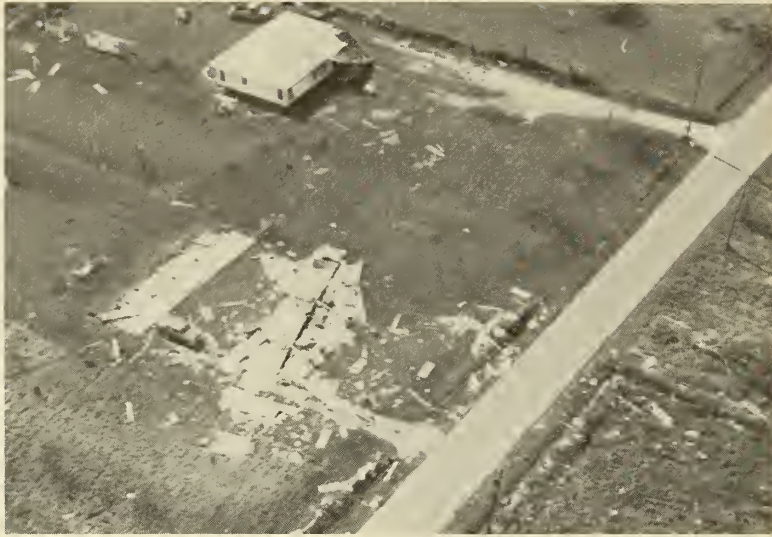
The remains of a mobile home in the same general area are shown in figure 42. The areas shown in the figures 40-42 are relatively clear of large trees, a fact which probably reduced the intensity of damage.

Figure 42. Remains of mobile home, Long Beach.

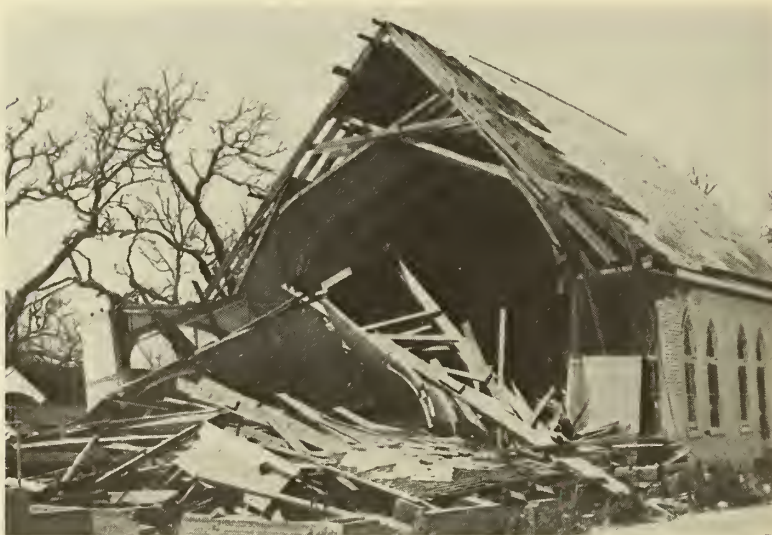
Figure 43. Saint Thomas Catholic Church, Long Beach, Mississippi.

Figure 43 shows a wood-frame church which was badly damaged by wave action. Commercial buildings located in a shopping center on U.S. Highway 90 are shown in figures 44-46. A small store constructed with masonry walls and located on the coastal side from the supermarket shown in figures 45 and 46 was completely destroyed. The church building shown in the center background of figure 45 had considerable storm surge damage to its interior although its exterior walls and roof were only slightly damaged.

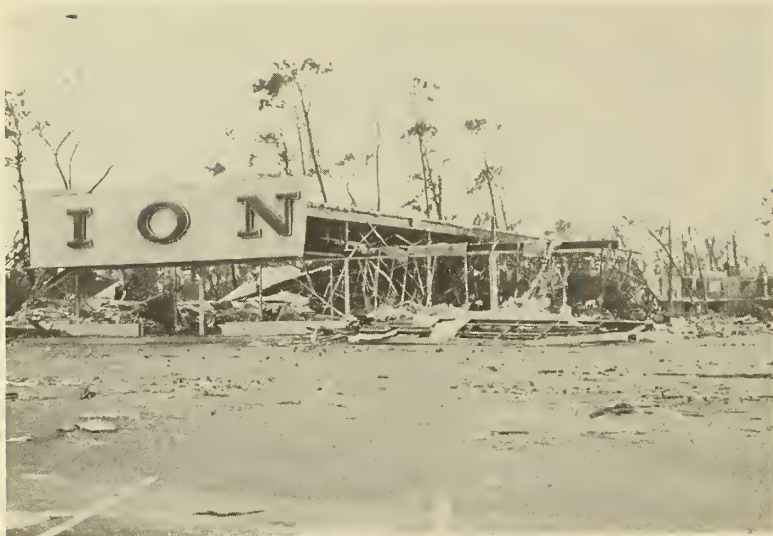
Figure 44. Commercial building, Long Beach. (Building is located across the street from shopping center shown in fig. 45).

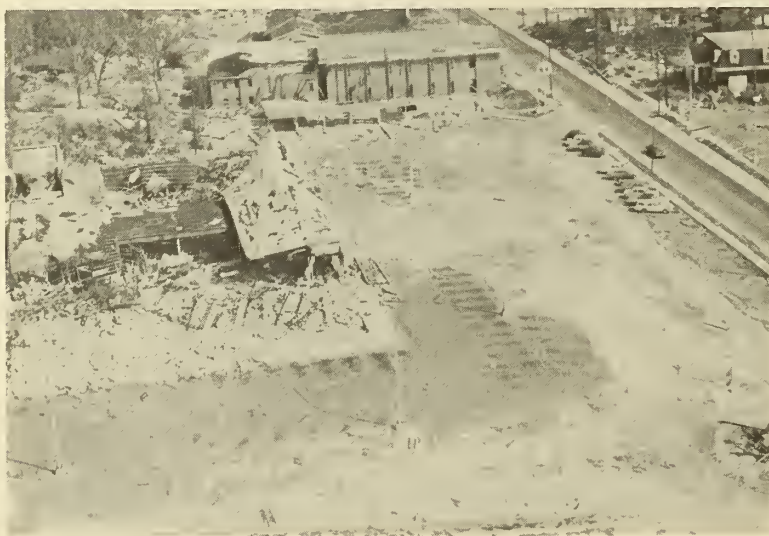
Figure 45. Shopping center, Long Beach, Mississippi.

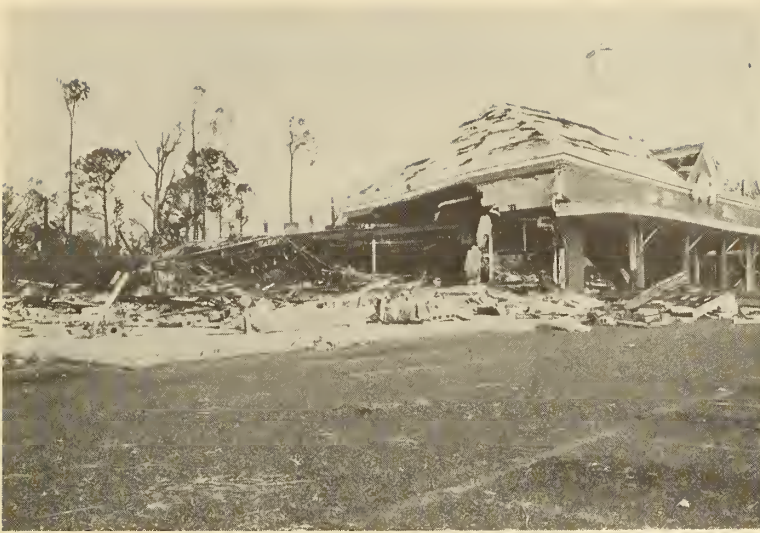
Figure 46. Close-up view of supermarket shown in figure 45.

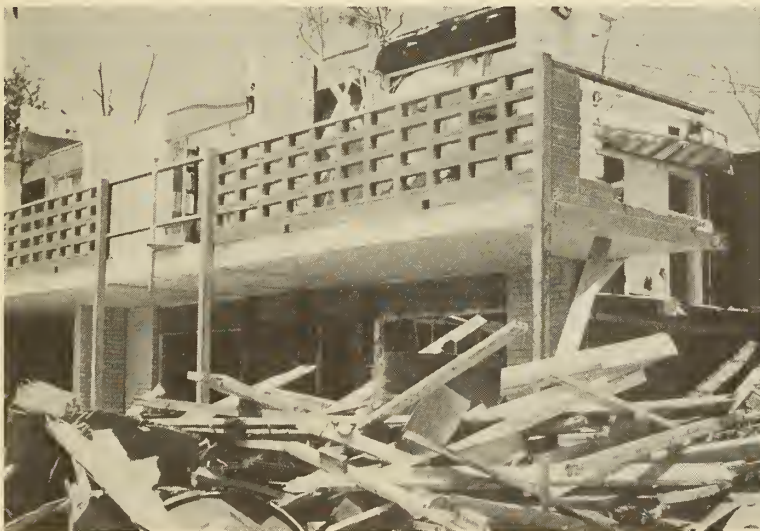
Water-borne debris piled up in front of a damaged masonry veneer wood-frame building (probably a motel) is illustrated in figure 47.

Figure 47. Close-up view of residential building, Long Beach, Mississippi.

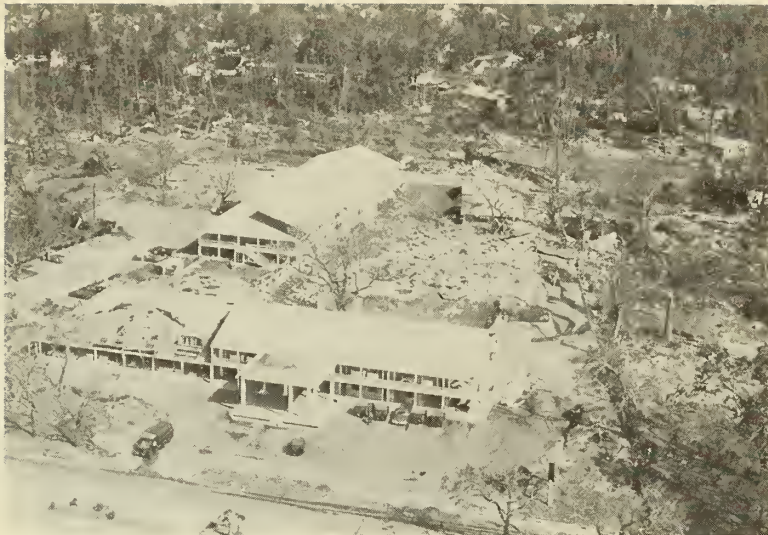
Ramada Inn - This motel (fig. 48) consists of a main building parallel to the highway (U.S. Route 90) plus two wings perpendicular to and behind the main building. As shown in figure 48, the motel wing on the right (east wing) suffered more damage than the other wing, probably because of its clearer exposure to the waves. The main building including

Figure 48. Ramada Inn, Long Beach, Mississippi.

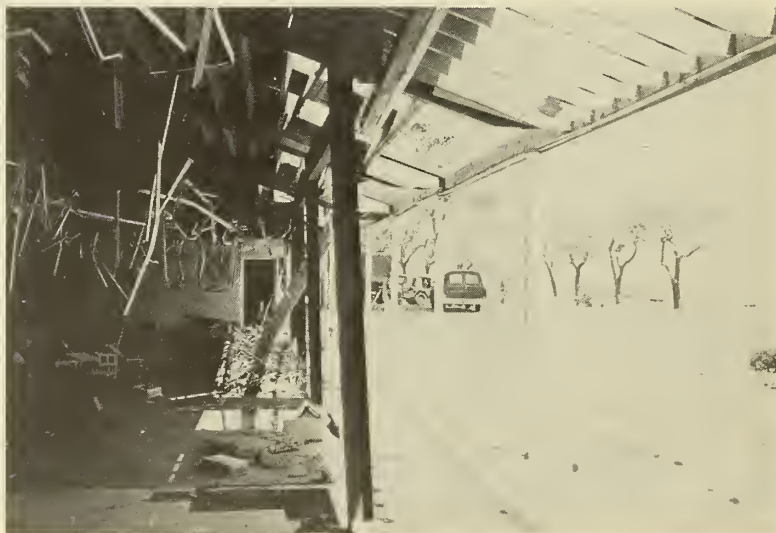
Figure 49. Restaurant area on west end of main building, Ramada Inn, Long Beach.

the restaurant area (fig. 49) experienced extensive water damage. On the east end of the main building, the top-story portion of a masonry wall had collapsed (fig. 50). An inspection of this brick and block wall indicated it contained some vertical reinforcement; however, the block cells containing this reinforcement did not contain any grout or concrete (fig. 51).

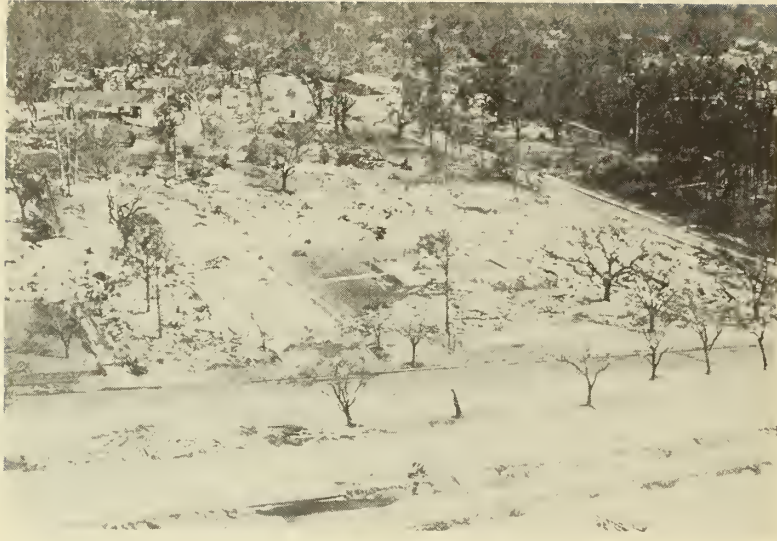
Figure 52. Residential area along coast, Long Beach, Mississippi.

Figures 52 and 53 illustrate the total destruction of numerous small residential buildings along the Long Beach and Pass Christian coastal area. The distance which the storm surge traveled inland is also evident in these figures.

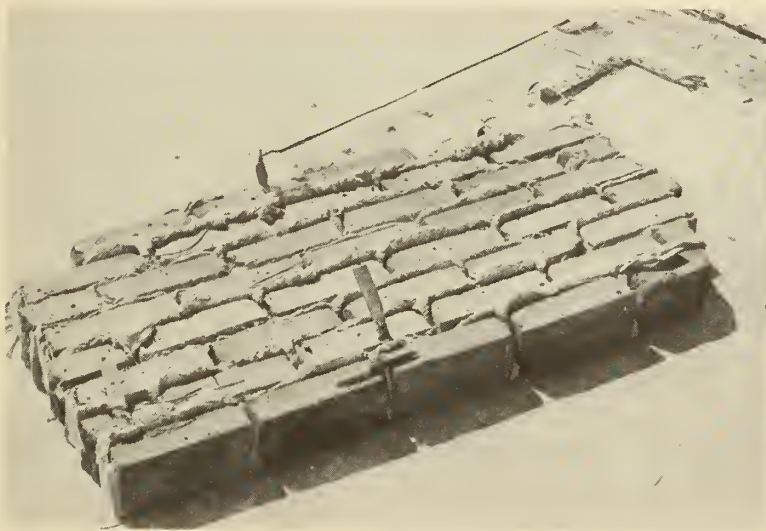
Along the coastal area in Pass Christian, several apartment buildings were totally destroyed by wave action. One of these buildings was the Richelieu Apartments (fig. 54) where 23 persons were killed because they failed to heed warnings to evacuate. A close-up view of the remains of the Richelieu Apartments, a three-story brick veneer and wood-frame building is shown in figure 55.

Figure 55. Debris from Richelieu Apartments, Pass Christian, Mississippi.

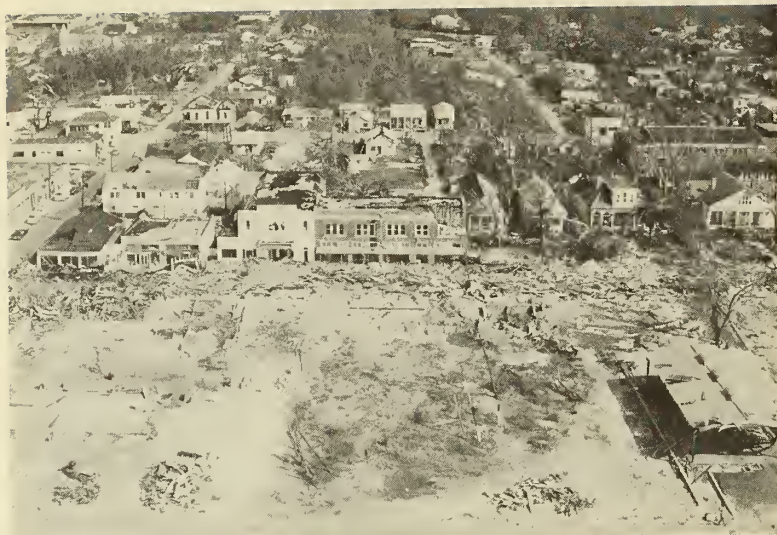
A residential area of Pass Christian is shown in figure 59. Fallen trees indicate that maximum winds were from the east (fastest mile speeds were probably in excess of 140 mph). The Pass Christian business

Figure 59. Residential area, Pass Christian, Mississippi.

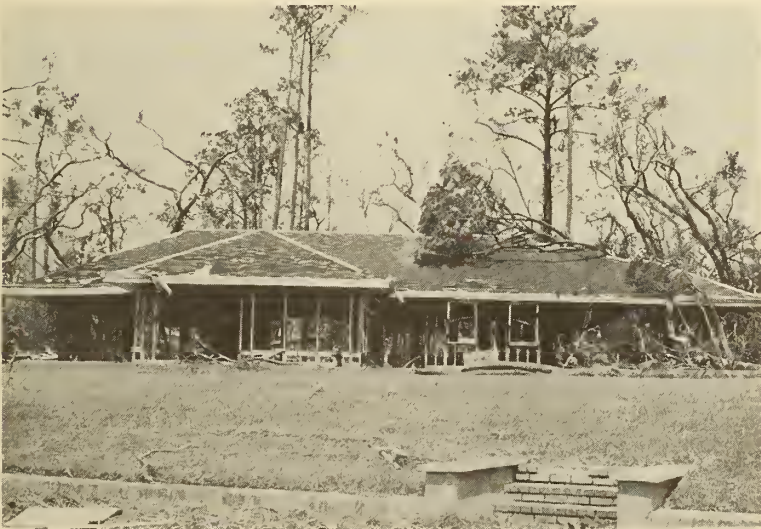
Figure 67. Single-family residence, Waveland, Mississippi.

A residence and a bank building, which were struck by waves, are illustrated in figures 67 and 68. The residential building lost most of its exterior and interior wall coverings but the good anchorage of the wood-stud walls to the concrete slab foundation and to the timber roof prevented total destruction. As shown in figure 68, the bank building was completely destroyed except for the reinforced concrete vault and building frame.

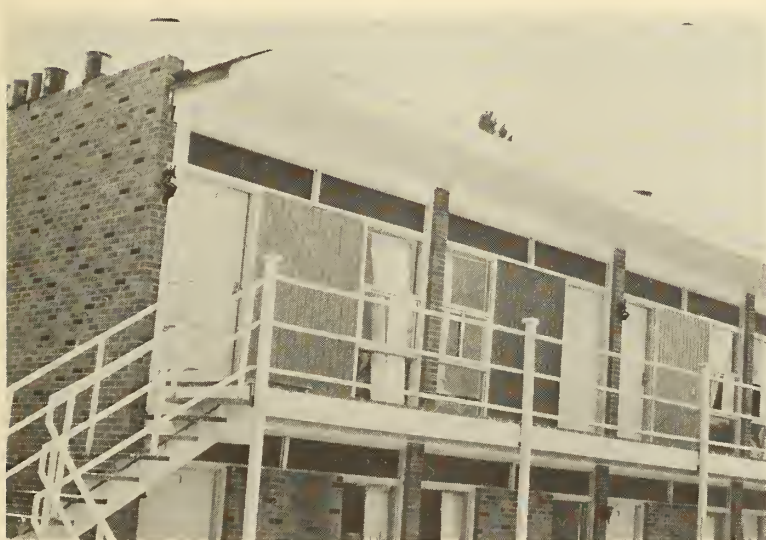
A small two-story motel located about 3 miles from the coast and on U.S. Route 90 near Waveland, Mississippi, is shown in figure 69. This brick-veneer and wood-frame building was arranged in a U-shaped plan and had a flat roof overhanging the second floor exit balcony. The direction of the wind was such that it resulted in one wing of the motel losing only part of its built-up roofing (fig. 69), while the other motel wing (fig. 70) was stripped of its entire roof structure due to the uplift forces acting on the roof overhang.

Figure 69. Motel near Waveland, Mississippi.

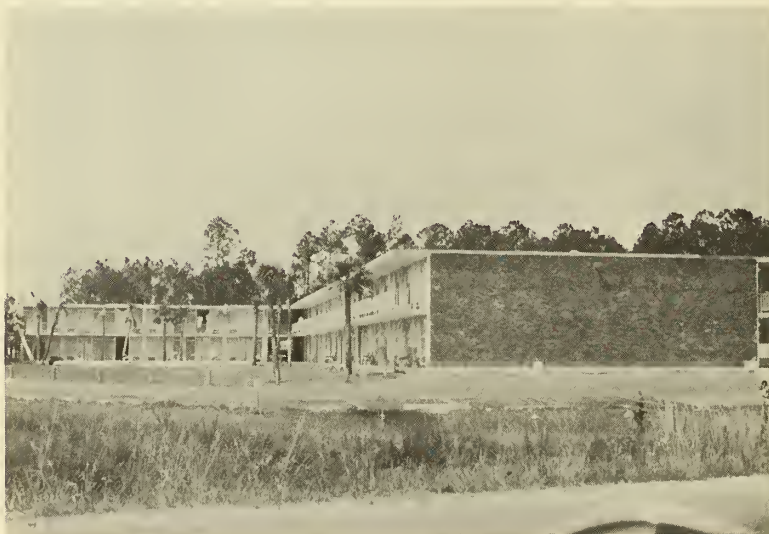
Across the highway from the small motel is a larger two-story motel, which has a flat concrete roof overhanging the second-story balcony (fig. 71). In this building the roof structure was apparently heavy enough and anchored satisfactorily to resist the uplift forces. The only damage observed was to the built-up roofing and underlying insulation.

Figure 71. Motel, U.S. Highway 90 near Waveland, Mississippi.

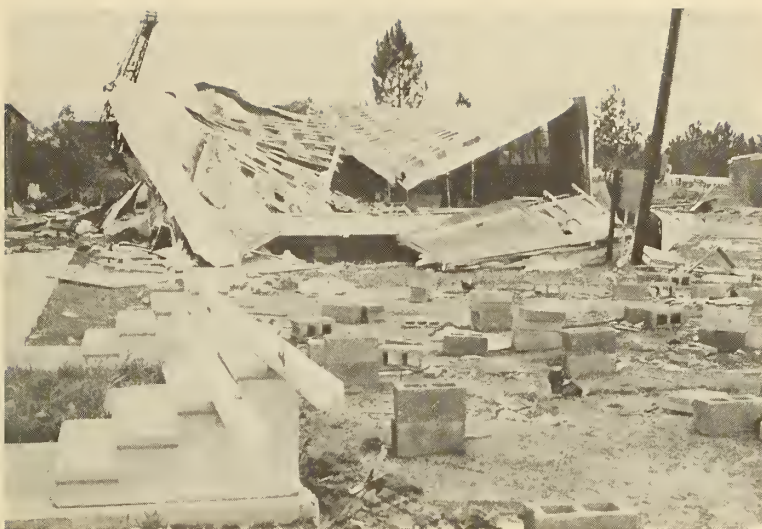
North Central High School is located on County Road 603 about 15 miles north of Waveland, Mississippi. The main school buildings are constructed with brick and block walls and a steel joist roof system. As shown in figure 73, the roof covering and insulation were stripped from the buildings and the windows were badly damaged. This exterior damage also resulted in extensive rain damage to the interior and contents of the buildings.

Figure 73. North Central High School between Waveland and Poplarville, Mississippi.

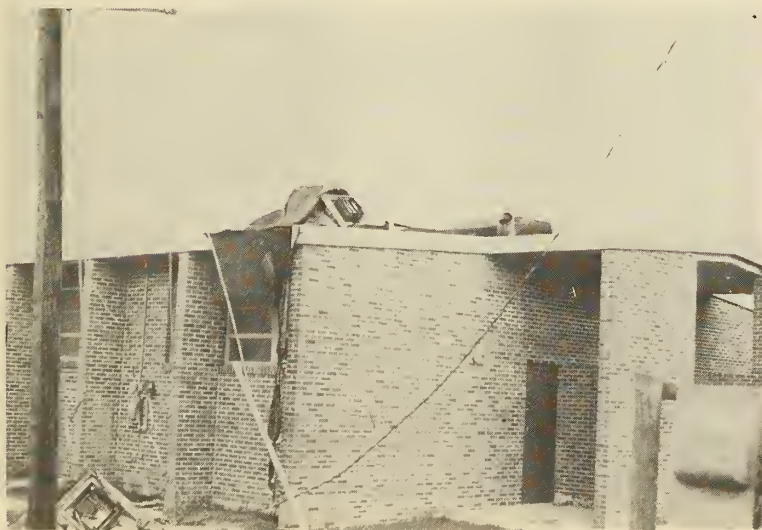
A smaller masonry building containing athletic locker rooms lost most of its built-up roof covering (fig. 75). It appeared that the wind probably tore off the roof vents first which then made the roof covering more vulnerable to wind action.

Figure 75. Athletic building, North Central High School.

(regardless of type) appeared to experience more damage (figs. 24 and 75). In a majority of cases, built-up roofing damage appeared to commence at the perimeter of the roof. Lack of adequate perimeter attachment was evident where serious damage was observed. In one building (fig. 75) the loss of roof exhaust vents probably caused the removal of considerable built-up roofing.

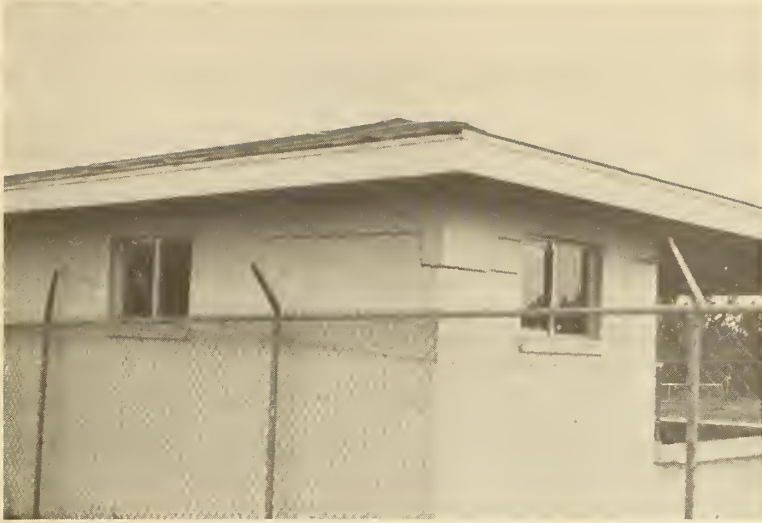
A small concrete block building (fig. 76) near the other school buildings had a wood-frame roof which was adequately anchored to the walls. Wind uplift on the roof did produce some major tensile cracks in the horizontal mortar joints of the walls.

Figure 76. Small concrete block building, North Central High School.

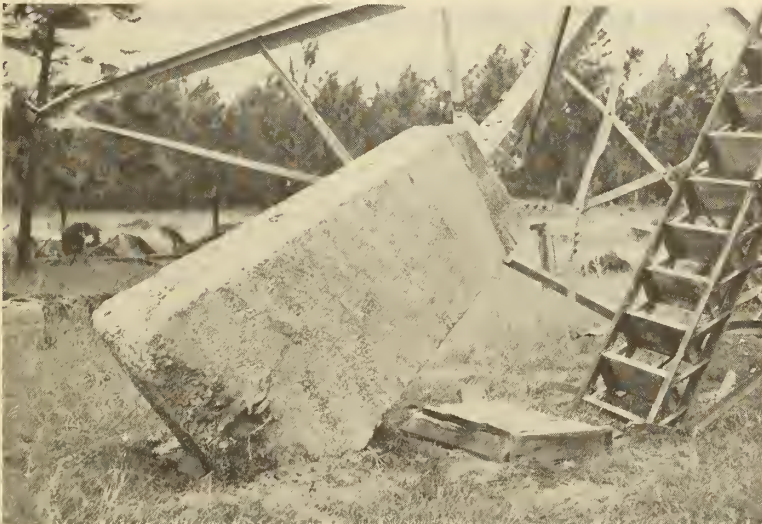
About five miles north of the North Central High School, a tall steel observation tower was toppled by the strong winds. One leg of the tower was sufficiently anchored to a concrete footing (fig. 77) to pull the footing from the ground and drag it about 15 ft when the tower overturned.

Figure 77. Steel observation tower near North Central High School.
